# **Commercialization of Technologies to Lower Defense Costs**

## **Final Demonstration/Validation Report For STAPP Bullet Catcher Evaluation at Fort A.P. Hill**

**March 2, 2006**

Report Number: NDCEE-CR-2006-001

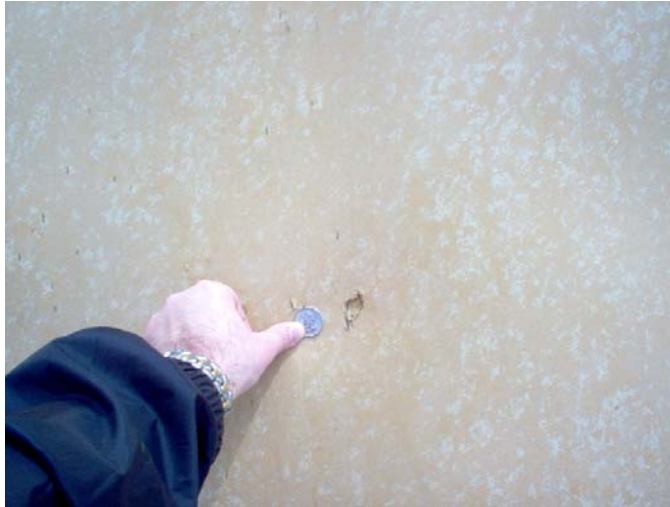
The top rubber cover had a small v-shaped tear approximately the size of a US quarter (See Figure 33). There was not a gaping hole, just a tear. It is believed that a tumbling bullet that had hit the target frame prior to the top rubber cover caused the tear. Mr. Mike Hargett of BAHF Training Group determined that no maintenance repairs were necessary at this time.

**Figure 33. Tear in Top Rubber Cover, Approximately the Size of a U.S. Quarter.**

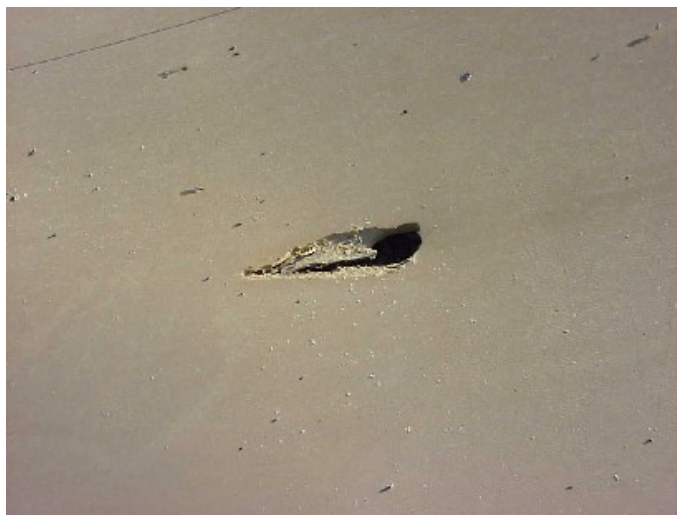
On 29 April 2004 all parties met at Range 5 to observe a small area on the left side of the Bullet Catcher that required patching (See Figure 34).

**Figure 34. Damage on Left Side of Range 5.**

Steps taken to repair the damaged area included sanding the perimeter of the damaged area and wiping it clean using rubbing alcohol. The repair patch

consisted of the very same material as the top rubber cover and was cut slightly larger than the damaged area to allow an approximate 1-2” overlap. The overlap provides a sound surface for the repair patch to adhere to. The under side of the repair patch was also sanded and cleaned with rubbing alcohol. Once the damaged area and patch were sanded and cleaned, a bead of the STAPP supplied glue was placed on both the perimeter of the damaged area as well as the coordinating under side of the patch. The patch was laid on top of the damaged area and hand-pressure was applied. The time required to complete the repair was approximately 5-7 minutes. For repair results see Figure 35.

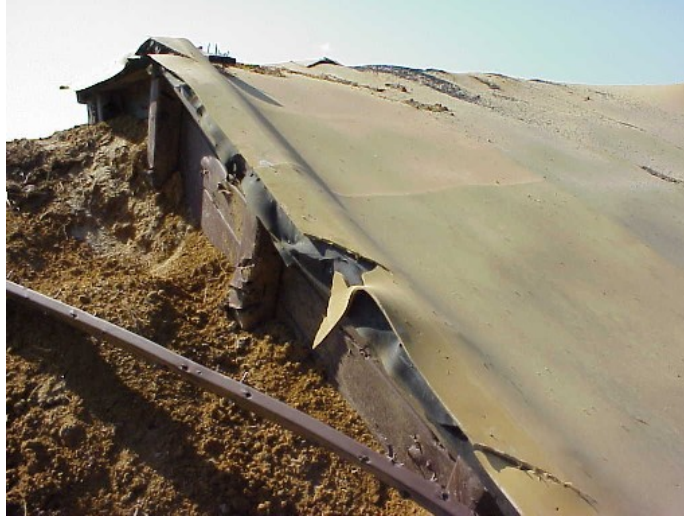
There was also damage along the left side of the Bullet Catcher just inside of the frame/planking, see Figure 37, which required the same repair steps previously mentioned.

**Figure 37. Left Side Damage to Top Rubber Cover and Frame/Planking on Range 5.**

The frame/planking was also damaged and a section needed to be replaced. After a replacement plank was cut to size it was screwed into place. The patch and plank replacement took approximately 25-30 minutes to complete.

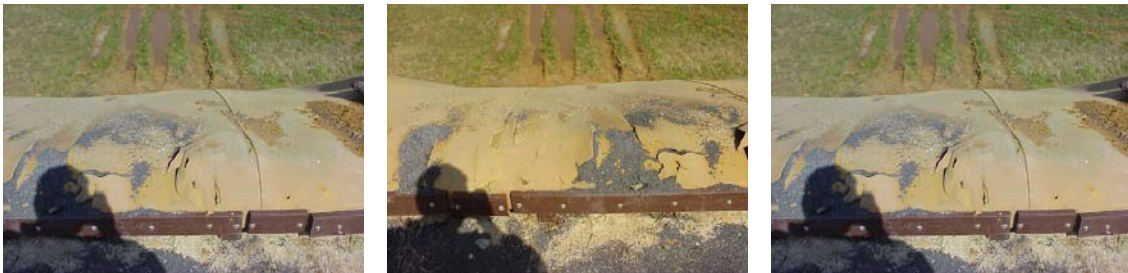
The top of the Bullet Catcher had severe damage to the upper portion of the top rubber cover (See Figures 38, 39, and 40).

**Figures 38, 39, and 40. Damage to the Upper Portion of the Top Rubber Cover of the Range 5 Bullet Catcher.**

The bullets hit the top portion of the Bullet Catcher because of the long distance between the firing point and the Bullet Catcher (approximately 271'). This large distance allows bullets to "travel" to the edges of the Bullet Catcher and beyond. Bullets that impact the Bullet Catcher at or near the edges are not able to penetrate the Bullet Catcher properly and therefore cannot be appropriately retained. The top portion of the Bullet Catcher, where it becomes flat, showed the most damage. Bullets that were fired at an upward angle or from the prone position caused this damage. When the bullets finally reach the Bullet Catcher they have traveled roughly 271' and have had the opportunity to "climb". The bullet then lightly penetrates the flattened out portion of the Bullet Catcher and simply skims the top rubber cover, tearing it as it passes. This damage is not due to a malfunction or inadequacy of the Bullet Catcher to perform, but is a direct result of the range design. Perhaps if the Bullet Catcher had been designed and constructed several feet taller this damage would not be an issue.

The top portion of the Bullet Catcher was patched. Steps taken to repair the damaged area were the same as for the smaller patches. Two large repair patches were needed for this top portion. Approximately 25-30 minutes were required to repair the entire top portion of the Bullet Catcher.

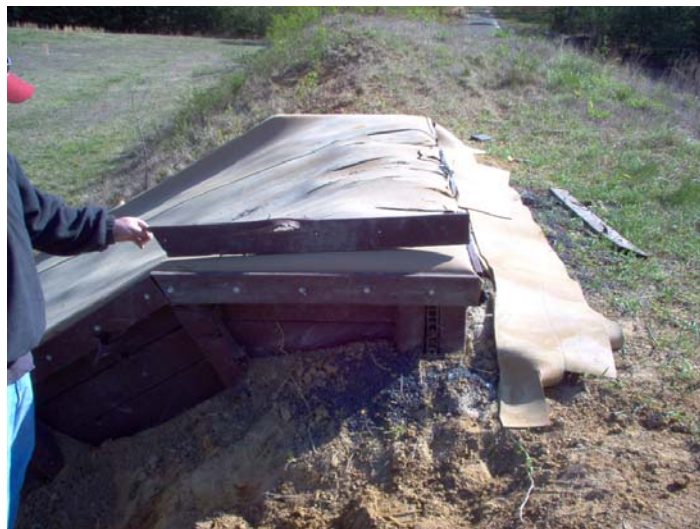
There was also a small piece of planking on the top left corner as well as a small damaged area of planking on the top right corner that needed to be replaced (Figure 41 shows the replacement planking for the right side.). After each piece of replacement planking was cut to size it was screwed into place. These repairs required approximately 5 minutes per section to complete.

**Figure 41. Damaged Frame/Plank Above-Replacement in Place Below.**

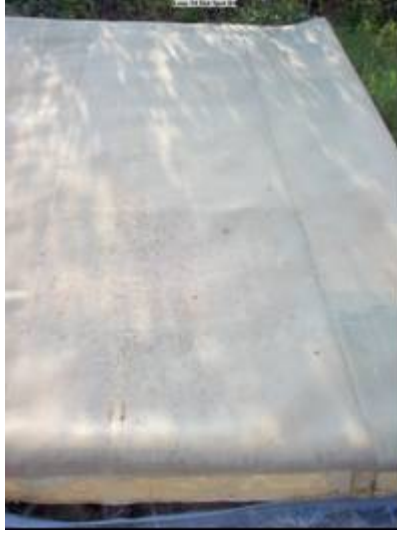
The bullets that impacted the Bullet Catcher on Range 4 were confined to “hot spots.” In this instance a hot spot is an area with a high concentration of bullets/entry marks. Each lane had a hot spot approximately 70” (height) x 50” (width) located towards the lower section of the Bullet Catcher (Figure 46).

**Figure 46. Range 4, Lane 54 Hot Spot.**
